Bell, John McLelland

Crash of Supermarine Stranraer 916,
Stuart Channel, BC, Canada

Details of Crash

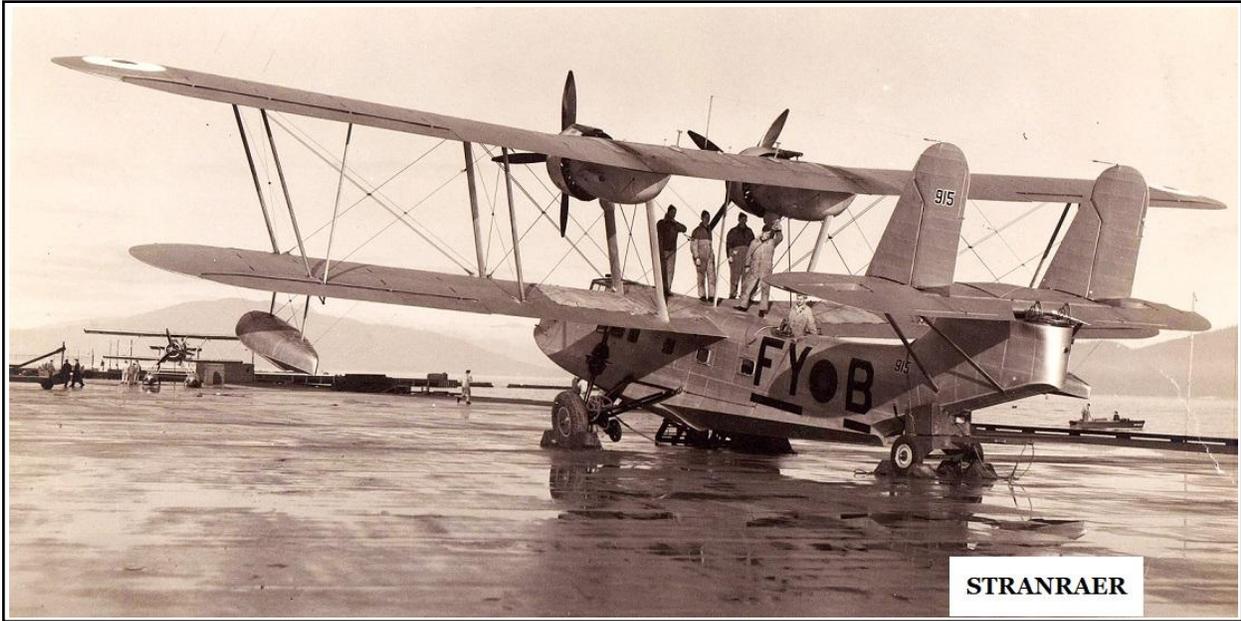
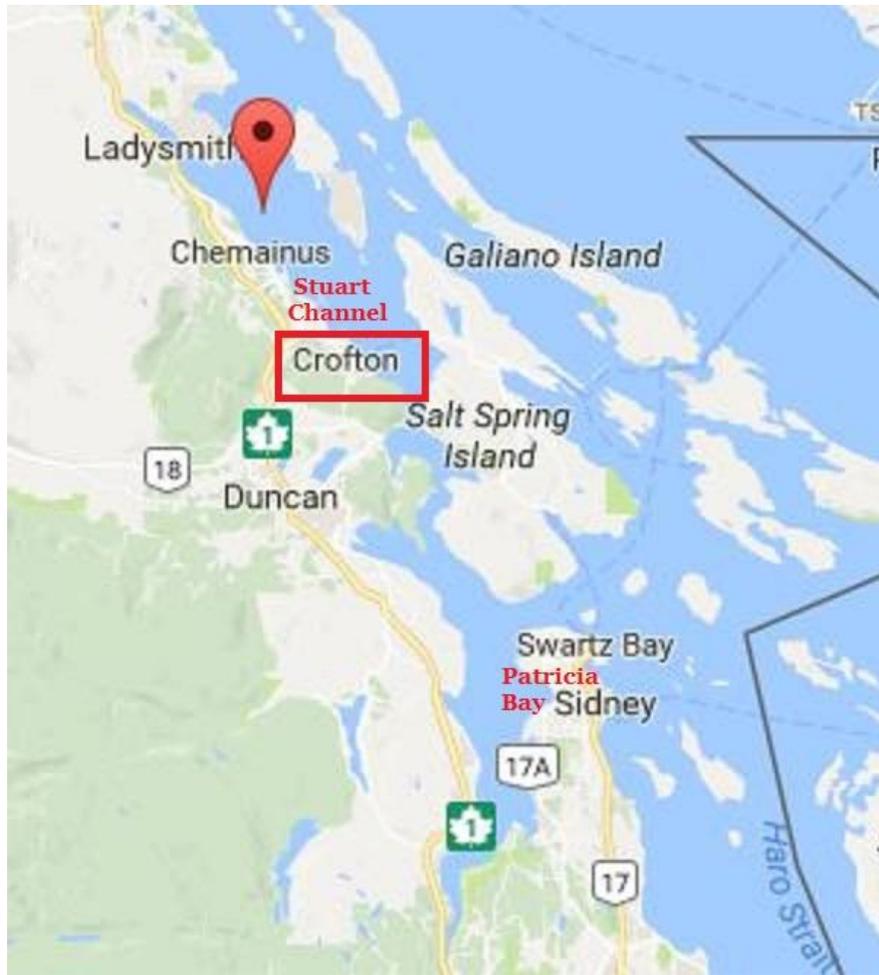
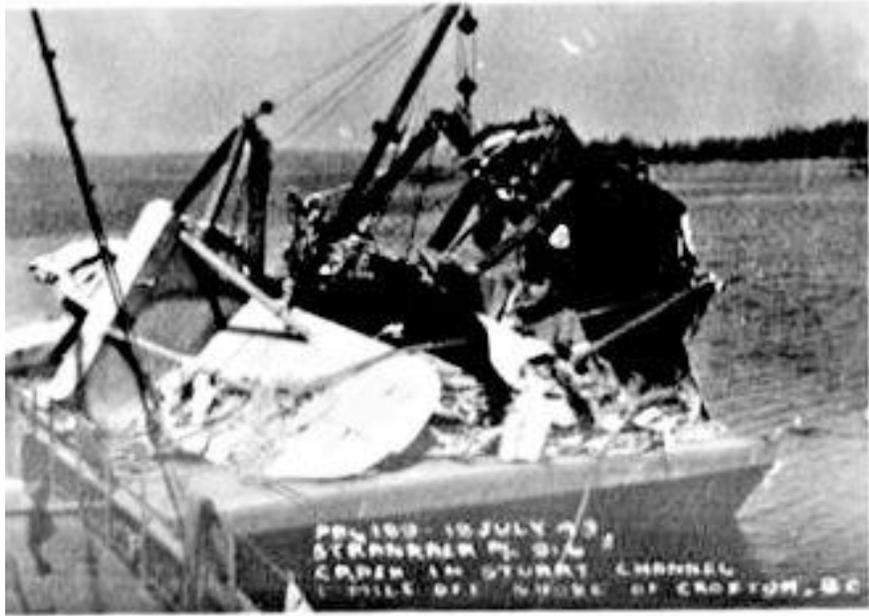
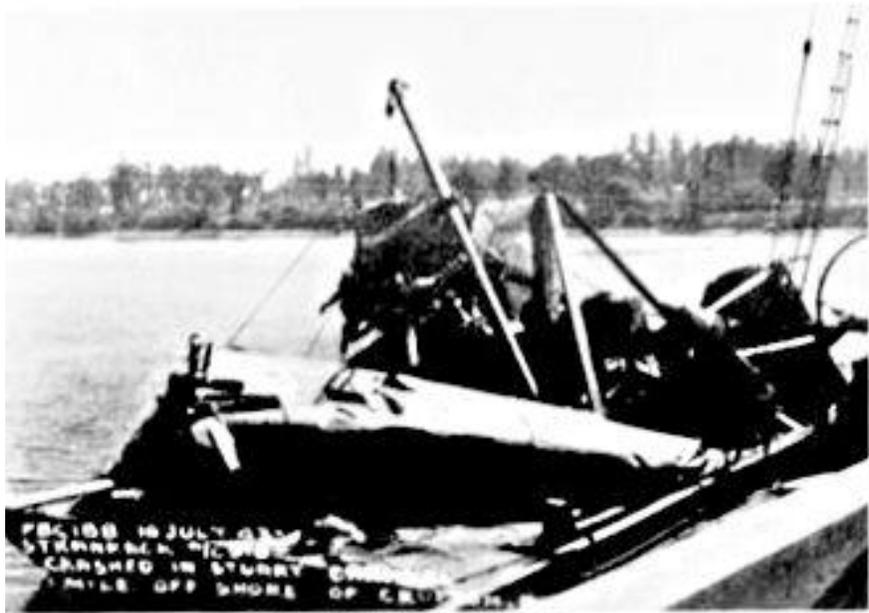
PC 159 10 JULY 43

Prior to the accident, the aircraft was in perfect serviceable order and all of the crew had Mae Wests. When the severely damaged aircraft was salvaged on 24th July, the body of LAC Bell was still in the fuselage. The Medical Officer who examined him was of the opinion that he had suffered concussion rendering him unable to escape and had thus drowned. No trace was ever found of F/S McCarty.

These are photographs referred to in the evidence of Mr. Hill, witness and taken at 10:15 AM on 10 July 1943 by Mr. Hill, witness.

Stranraer 916 during salvage
